20 December 2021

Mark C. Spear, P.E.
Pape Dawson Engineers, Inc.
5810 Tennyson Parkway, Suite 470
Plano, Texas 75024

Re: Stephens Towne Center - Waters of the United States Delineation
Approximately 196+/- acres located at the southeast corner of Lois Lane and Interstate Highway
35 in the City of Sanger, Denton County, Texas

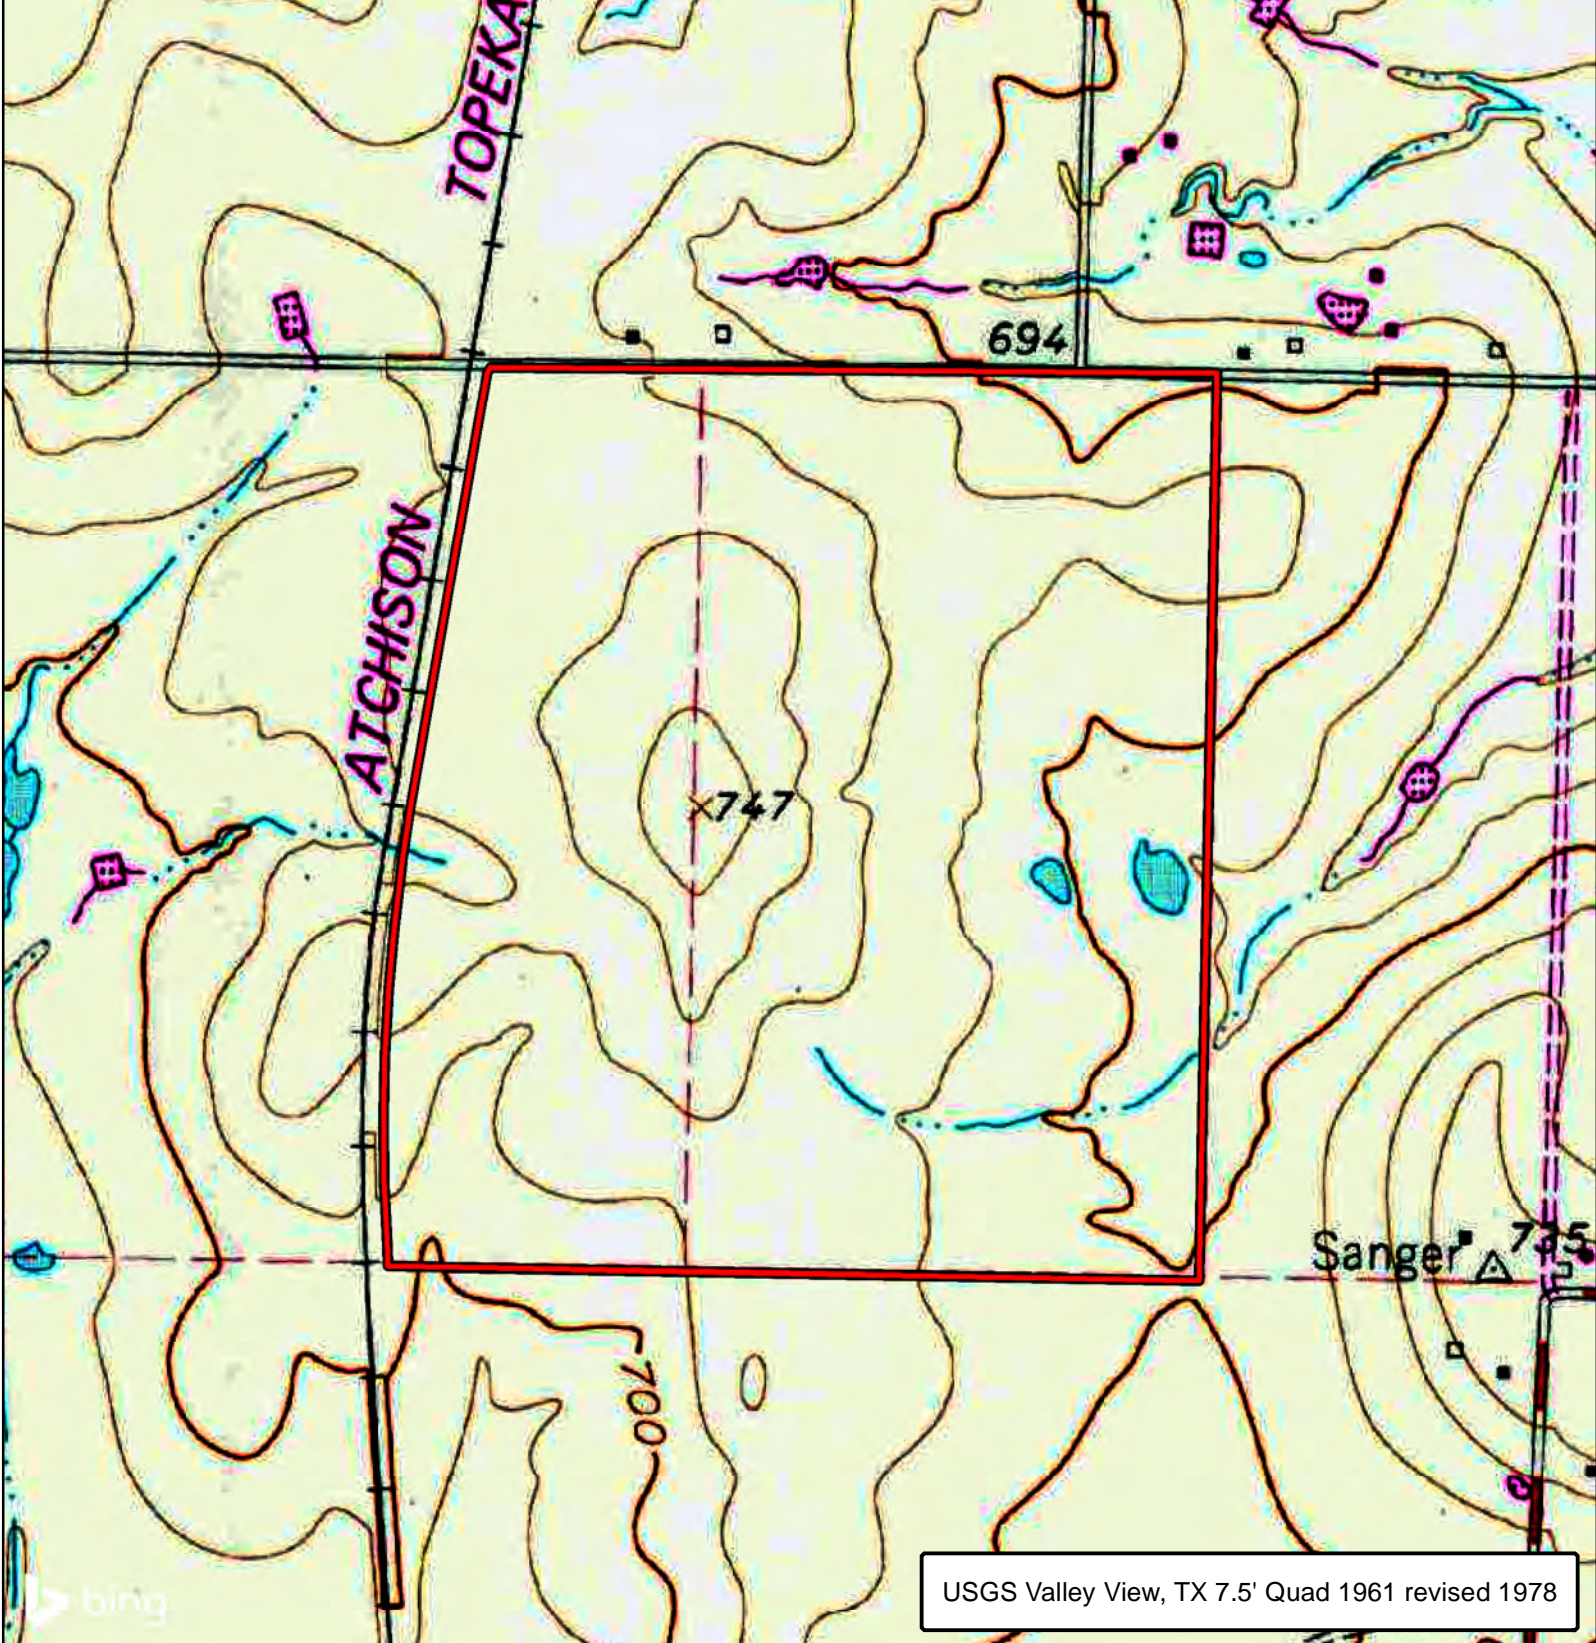
Figure 2A.
Topographic Setting

The USGS topographic map (Valley View, Texas 7.5' Quadrangle 1961, revised 1978) illustrates two blue line features and two ponds within the survey area. The first blue line feature is illustrated in the southeast with an overall west-to-east orientation. The second blue line feature begins along the western boundary and continues west. The two ponds are depicted in the eastern portion, north of the first blue line feature (see **Attachment A, Figure 2A**). The 2019 versions of the Valley View, Texas 7.5' Quadrangle map illustrates the blue line features and ponds within similar alignment (see **Attachment A, Figure 2B**). The overall topography of the site was illustrated with a hilltop in the west-central portion and slope oriented in all direction from the hilltop. The maximum elevation was approximately 740 feet above mean sea level (amsl) and a minimum elevation of approximately 690 feet amsl.

Prior to conducting fieldwork, the U.S. Geological Survey (USGS) topographic map (**Attachment A, Figures 2A and 2B**), the *Soil Survey of Denton County, Texas*, and the U.S. Department of Agriculture (USDA) Natural Resources Conservation Service (NRCS) digital soil databases for Denton County (**Attachment A, Figure 3**), the Federal Emergency Management Agency (FEMA) Flood Insurance Rate Map (FIRM) (**Attachment A, Figure 4**), and recent and historic aerial photographs of the proposed survey area were studied to identify possible aquatic features that could meet the definition of waters of the United States and areas prone to wetland development. Ms. Mackenzie Lyon and Ms. Emily Palsa of IES conducted the delineation in the field in accordance with the USACE procedures on 14 December 2021.

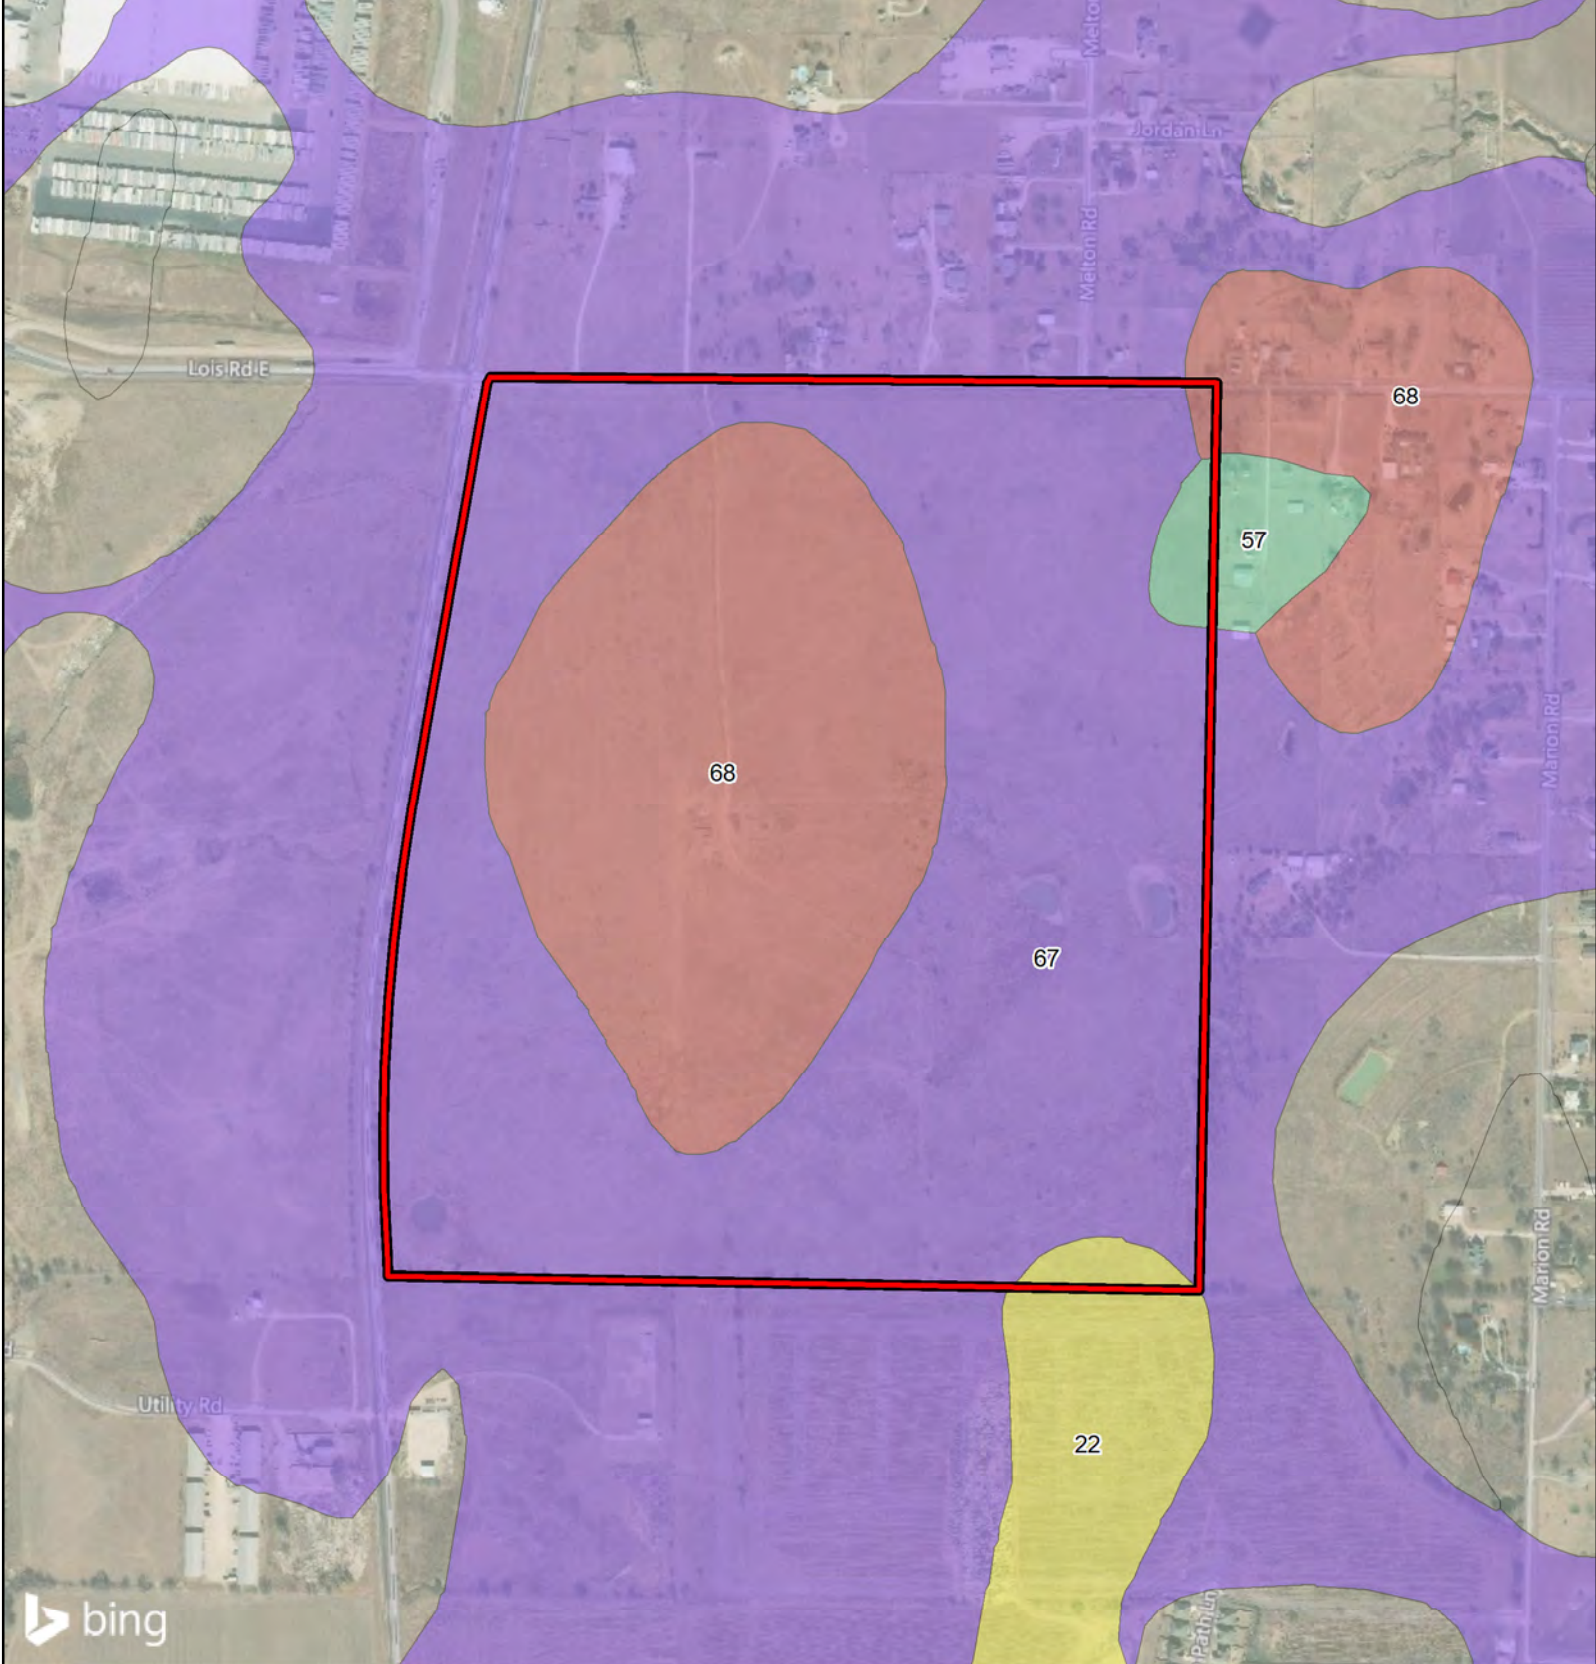
**Figure 3.
Soils Map**

The *Soil Survey of Denton County, Texas* identified four soil map units within the survey area, Burleson clay, 1 to 3 percent slopes; Medlin-Sanger stony clay, 5 to 15 percent slopes; Sanger clay, 1 to 3 percent slopes; and Sanger clay, 3 to 5 percent slopes. None of these soil map units were listed as a hydric soil on the Hydric Soils of Texas list prepared by the National Technical Committee for Hydric Soils (accessed 14 December 2021, Denton County, Texas) (see **Attachment A, Figure 3**). Hydric soils are described as those soils that are sufficiently wet in the upper part to develop anaerobic conditions during the growing season.

- Survey Area
- Soil map units outside the survey area
- Soil Map Units**
- 22 - Burleson clay, 1 to 3 percent slopes
- 57 - Medlin-Sanger stony clay, 5 to 15 percent slopes
- 67 - Sanger clay, 1 to 3 percent slopes
- 68 - Sanger clay, 3 to 5 percent slopes

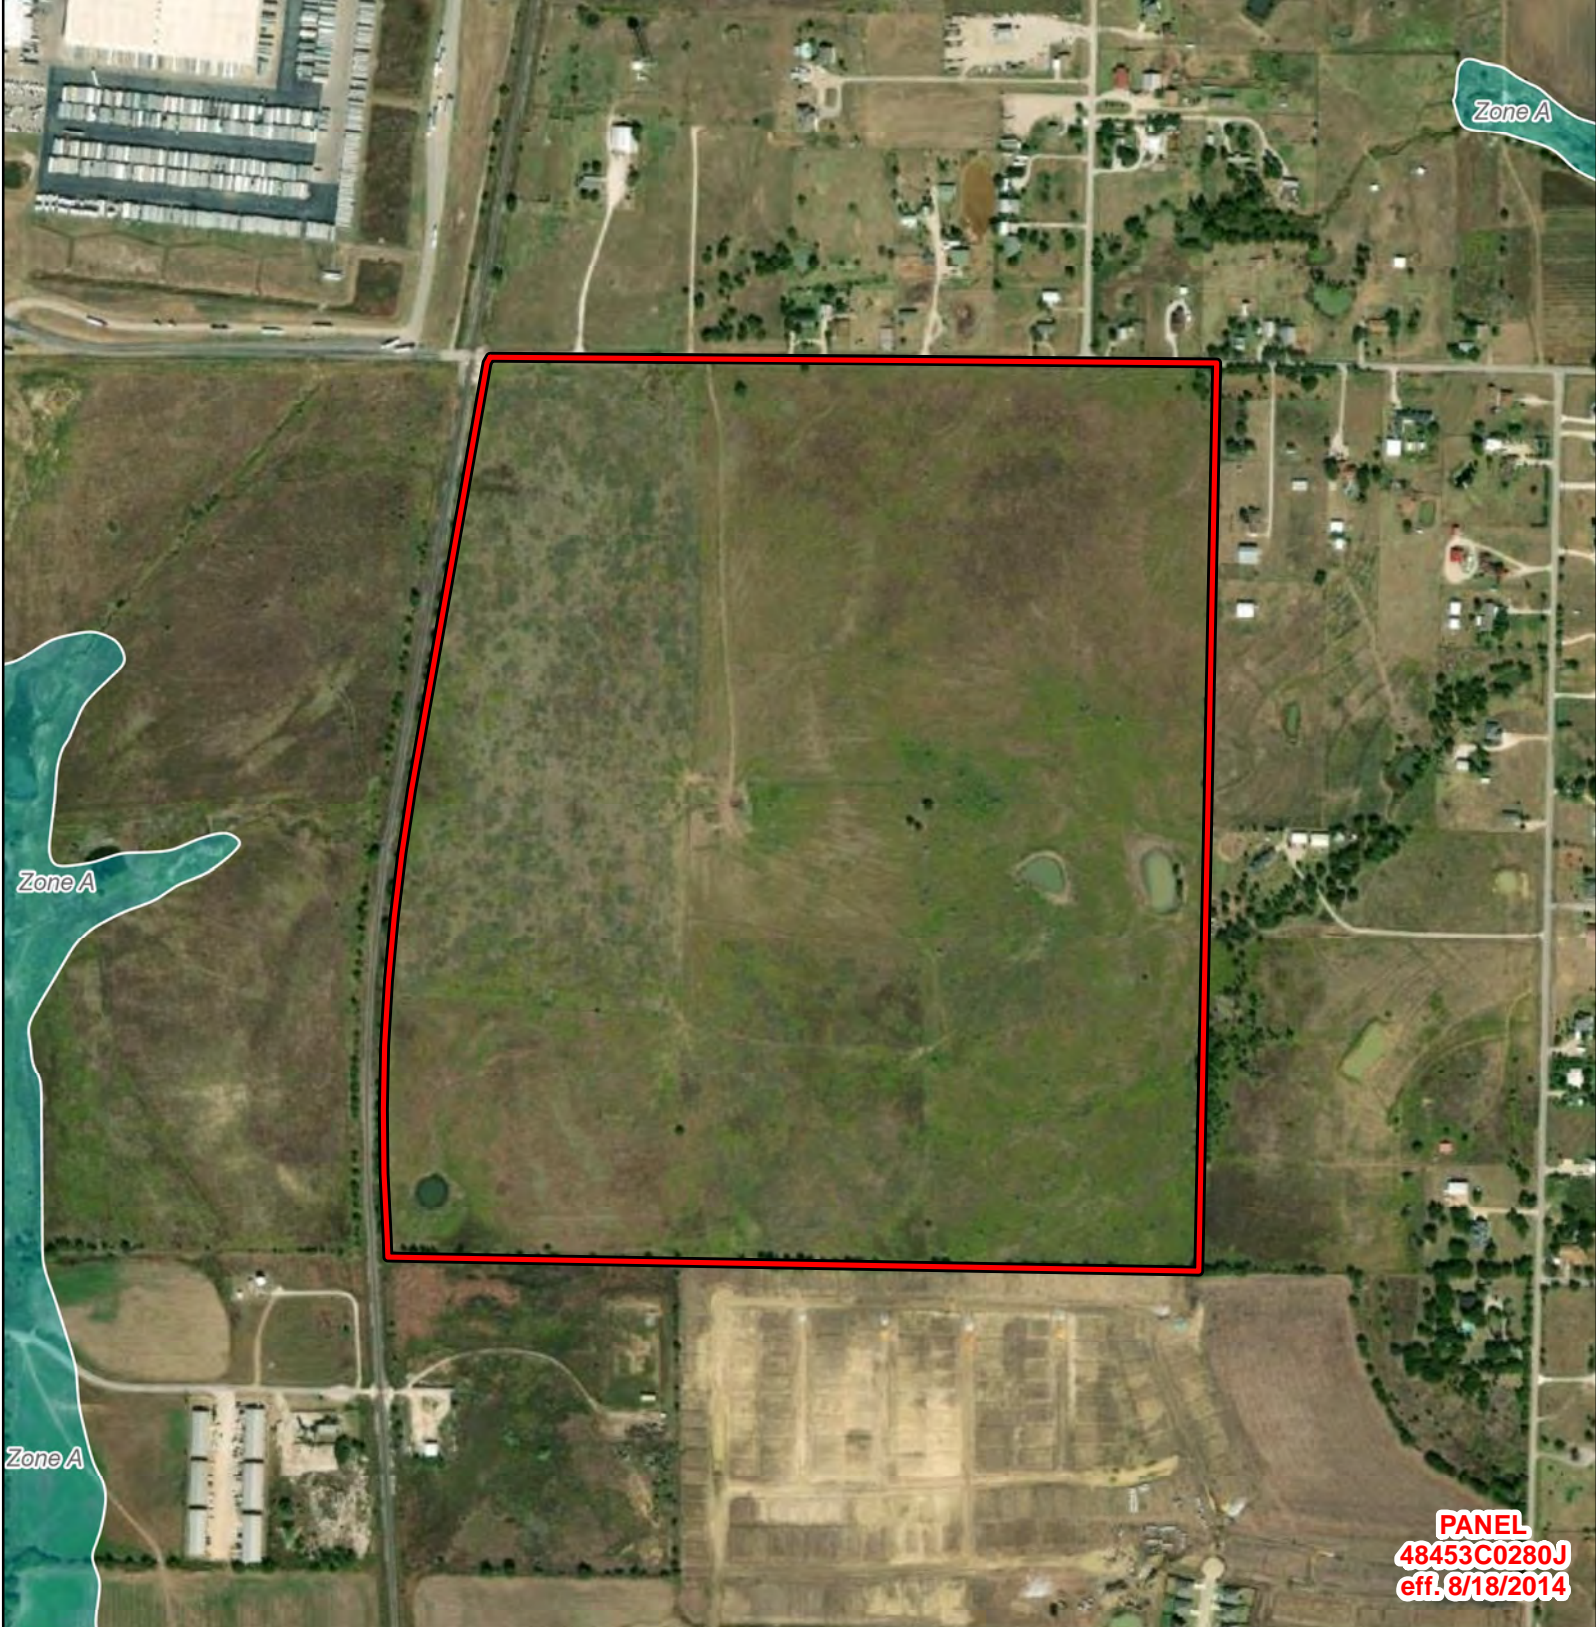
Figure 4.
Federal Emergency
Management Agency
Flood Insurance Rate Map

The FEMA FIRM (Denton County; Map Panel 48453C0280J; effective 18 August 2014) shows the entirety of the survey area to be within Zone X (Areas determined to be outside the 0.2 percent annual chance floodplain) (see **Attachment A, Figure 4**).

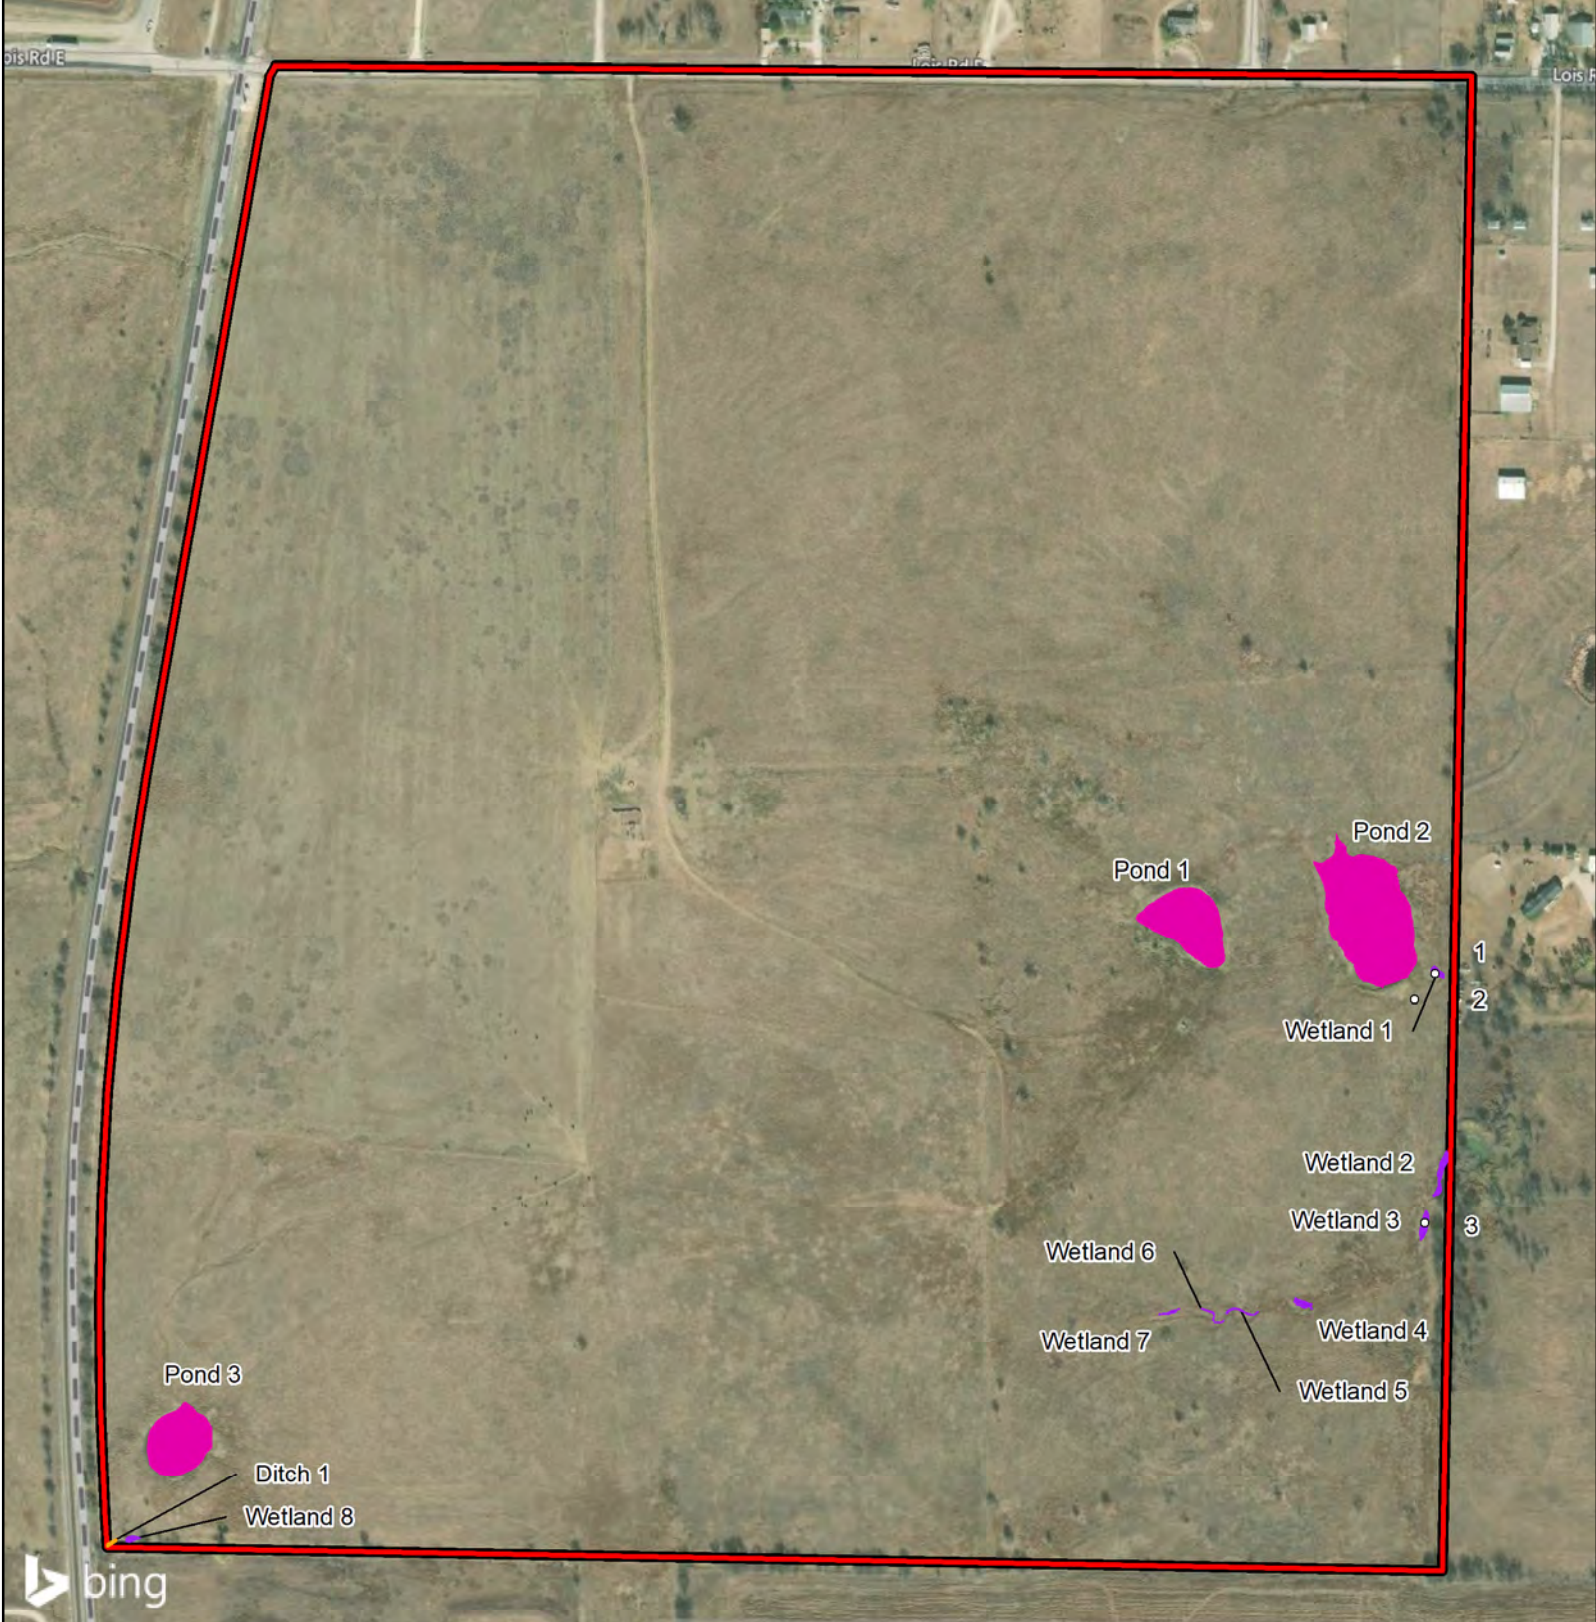
Figure 5.
Aquatic Features Identified
within the Survey Area

Water from the survey area flows east into Pond Creek, which flows into the Elm Fork Trinity River. The Elm Fork Trinity River ultimately flows into the Trinity River, a TNW. **Table 1** and the following paragraphs detail the aquatic features identified within the survey area at the time of evaluation (see **Attachment A, Figure 5**).

Wetlands 1 through 8 were small, isolated wetland swales located in the southern portion. Wetlands 1 through 8 were dominated by spikerush (*Eleocharis palustris*) and roughleaf cocklebur, both hydric plants. Wetland 1 was downslope of Pond 2 and appeared to receive hydrology from a seep from Pond 2's dam. Wetlands 2 through 7 were observed along the USGS blue line feature and meandering swales observed in historic aerial photography. Though the wetlands were identified in a conveyance, there was more upland area observed within the conveyance than wetland. Wetland 8 was observed in the far southwestern corner, south of Pond 3. Hydric soil was indicated by Depleted Matrix with a matrix of 10YR 4/1 with redoximorphic concentrations of 5YR 4/6 in the pore linings and matrix. Hydrologic indicators for Wetland 1, and 4 through 7 consisted of saturation, algal mat, and crayfish burrows. Indicators for Wetlands 2, 3, and 8 consisted of surface water, saturation, and an algal mat. Given these features' locations in the watershed, Wetlands 1 through 8 would likely only be seasonally saturated.

Ponds 1 through 3 were isolated, artificially excavated stock ponds located in the southern portion with no OHWM entering or exiting the ponds. The ponds' limits were identified by OHWM characteristics that included a natural line impressed in the bank, a water line, and a wrack line. A review of recent historical aerial photographs depict that the ponds have seasonal dry periods. As such, it is IES's professional opinion that Ponds 1 through 3 would be seasonally inundated.

Ditch 1 was identified as a channel along the western railway to convey stormwater from nearby roads, detention pond, and hillside sheet flow. The ditch was likely constructed at approximately the same time as the railway. A portion of the ditch, a plunge pool upslope, was inundated while majority of the ditch was dry at the time of evaluation. As such, it is IES' professional opinion that Ditch 1 would be considered to have ephemeral flow.

The 05 June 2007 USACE and USEPA jointly published instructional guidebook is intended to provide the USACE field staff a national standard operating procedure for conducting jurisdictional determinations. The guidebook was prepared by combining all prior applicable provisions, regulations, statutes, and case laws pertaining to the CWA. All terms, definitions, and conclusions regarding the jurisdictional nature of the aquatic features used within this report are derived directly, as they are practiced, from the guidance. The following outlines the applicable interpretations of the guidance appropriate for this situation. **Table 2** provides an overview of the jurisdictional assessment of the aquatic features under the 1986 Waters of the United States definitions and the *Rapanos* decision (**Attachment A, Figure 5**).

Under the **1986 waters of the United States definitions** and the *Rapanos* decision, **Wetlands 1 through 8**, and **Ponds 1 through 3** would be considered isolated and therefore would not be regulated under CWA Section 404. **Ditch 1** was not a replacement of, nor connected two waters of the United States, as such **Ditch 1** would not be regulated under CWA Section 404.

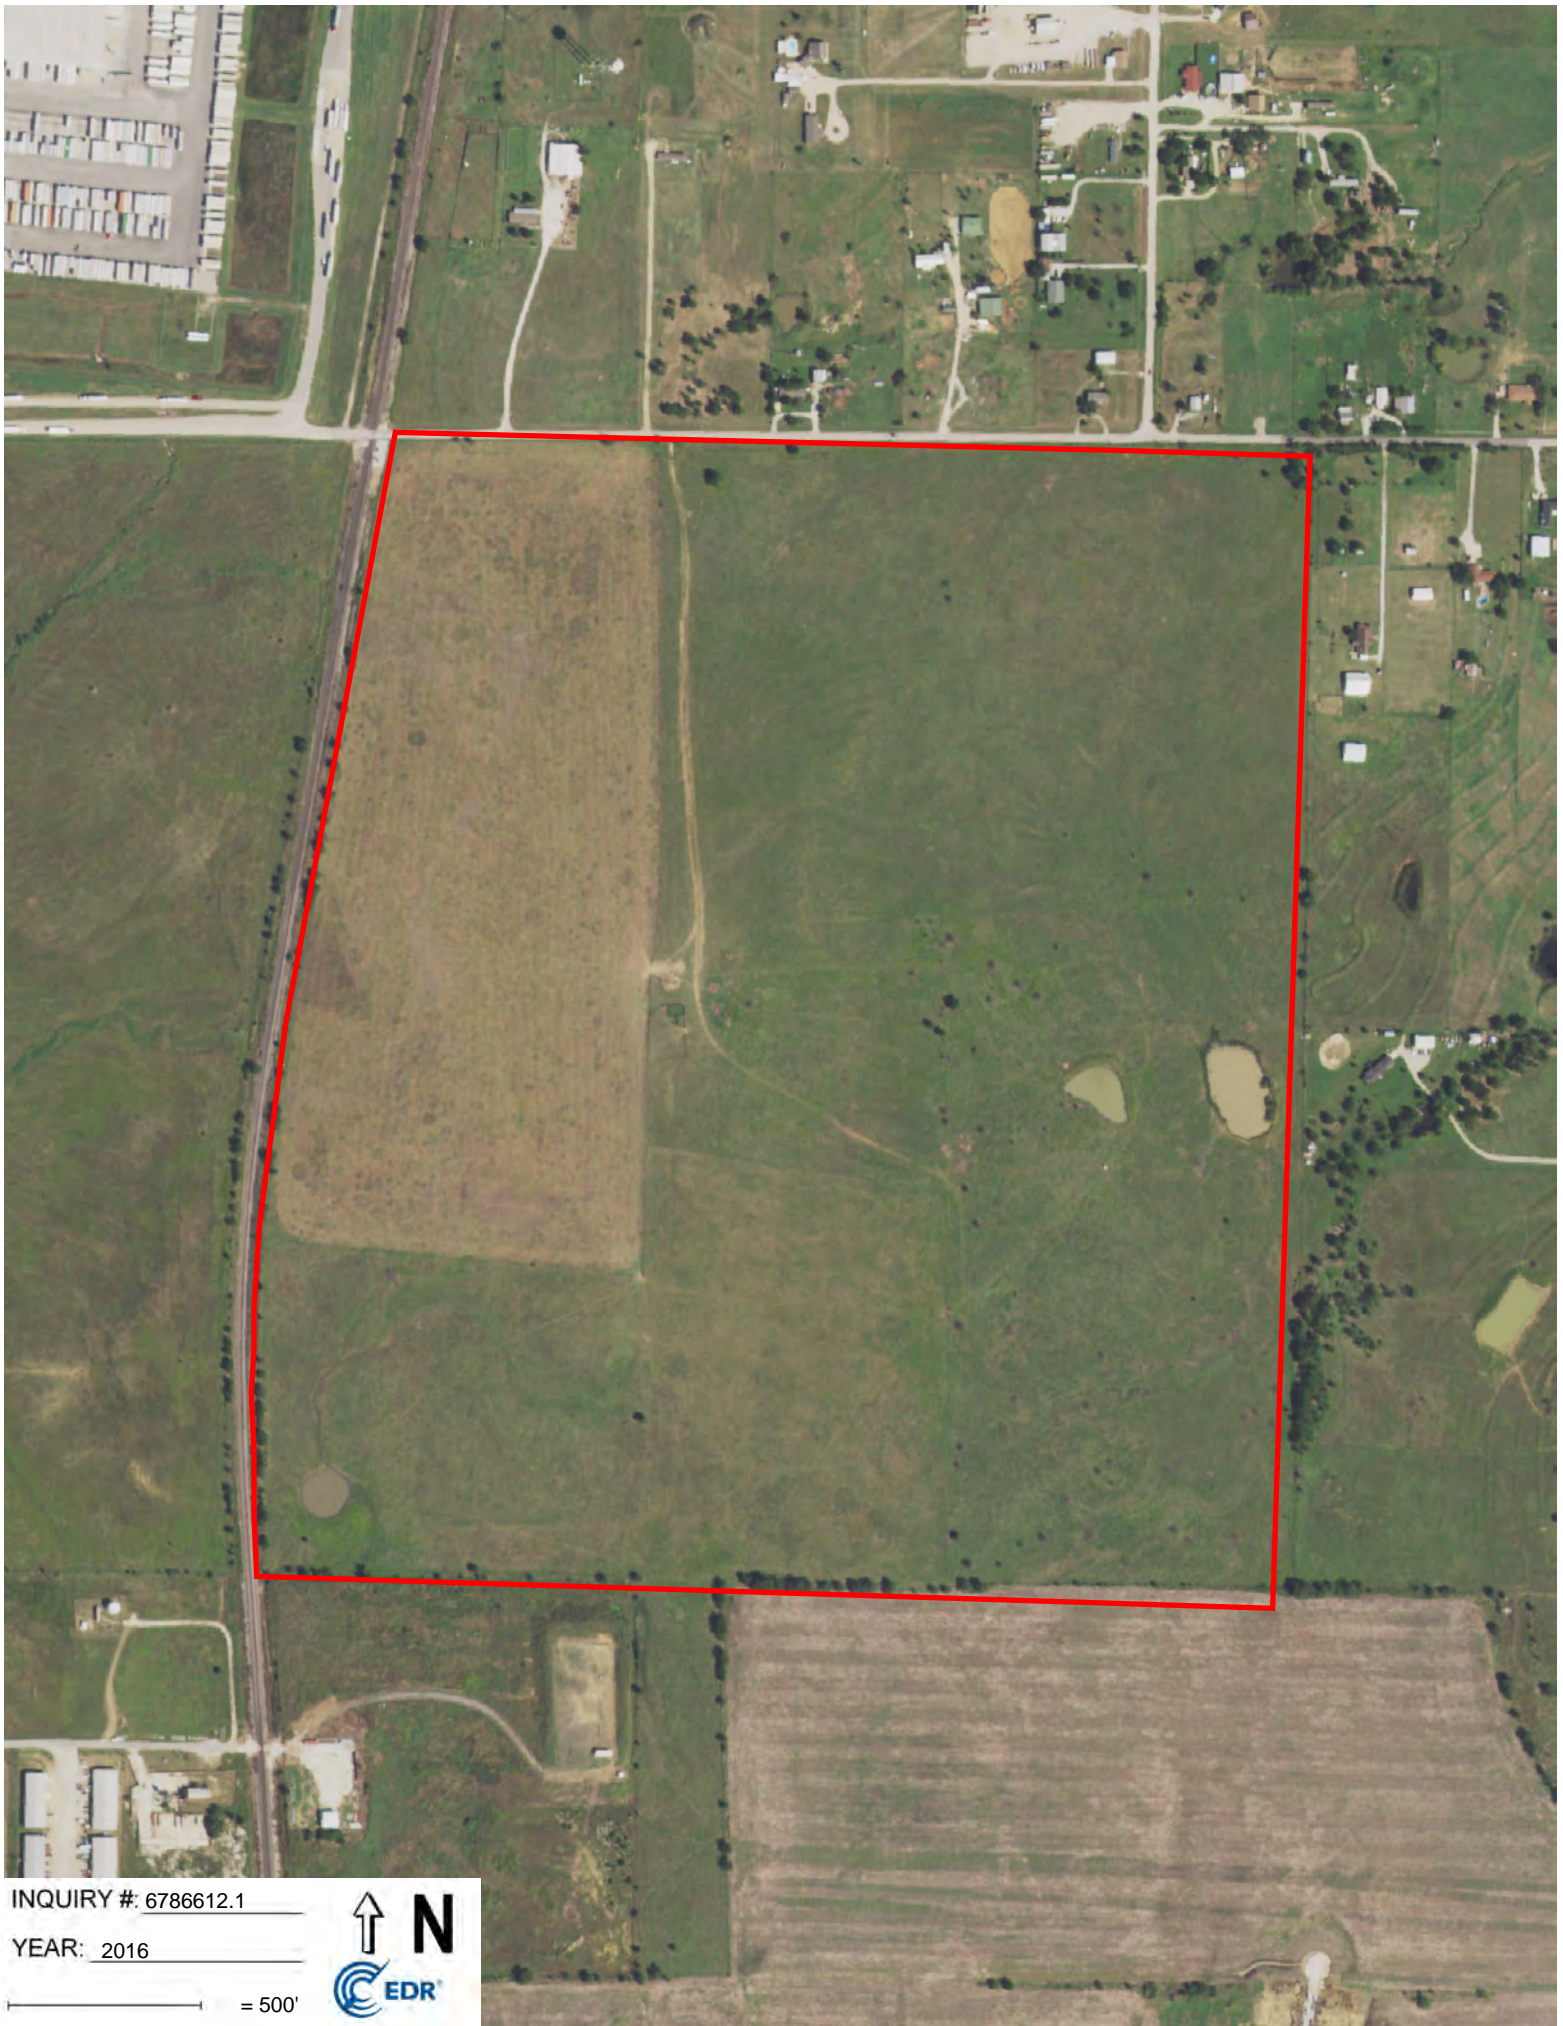
YEAR: 2016

2006-2016 – An additional isolated pond is illustrated in the southwestern corner. Sparse tree cover along fence lines and throughout the eastern half indicate a change from the plowed fields to pasturelands and hay production.

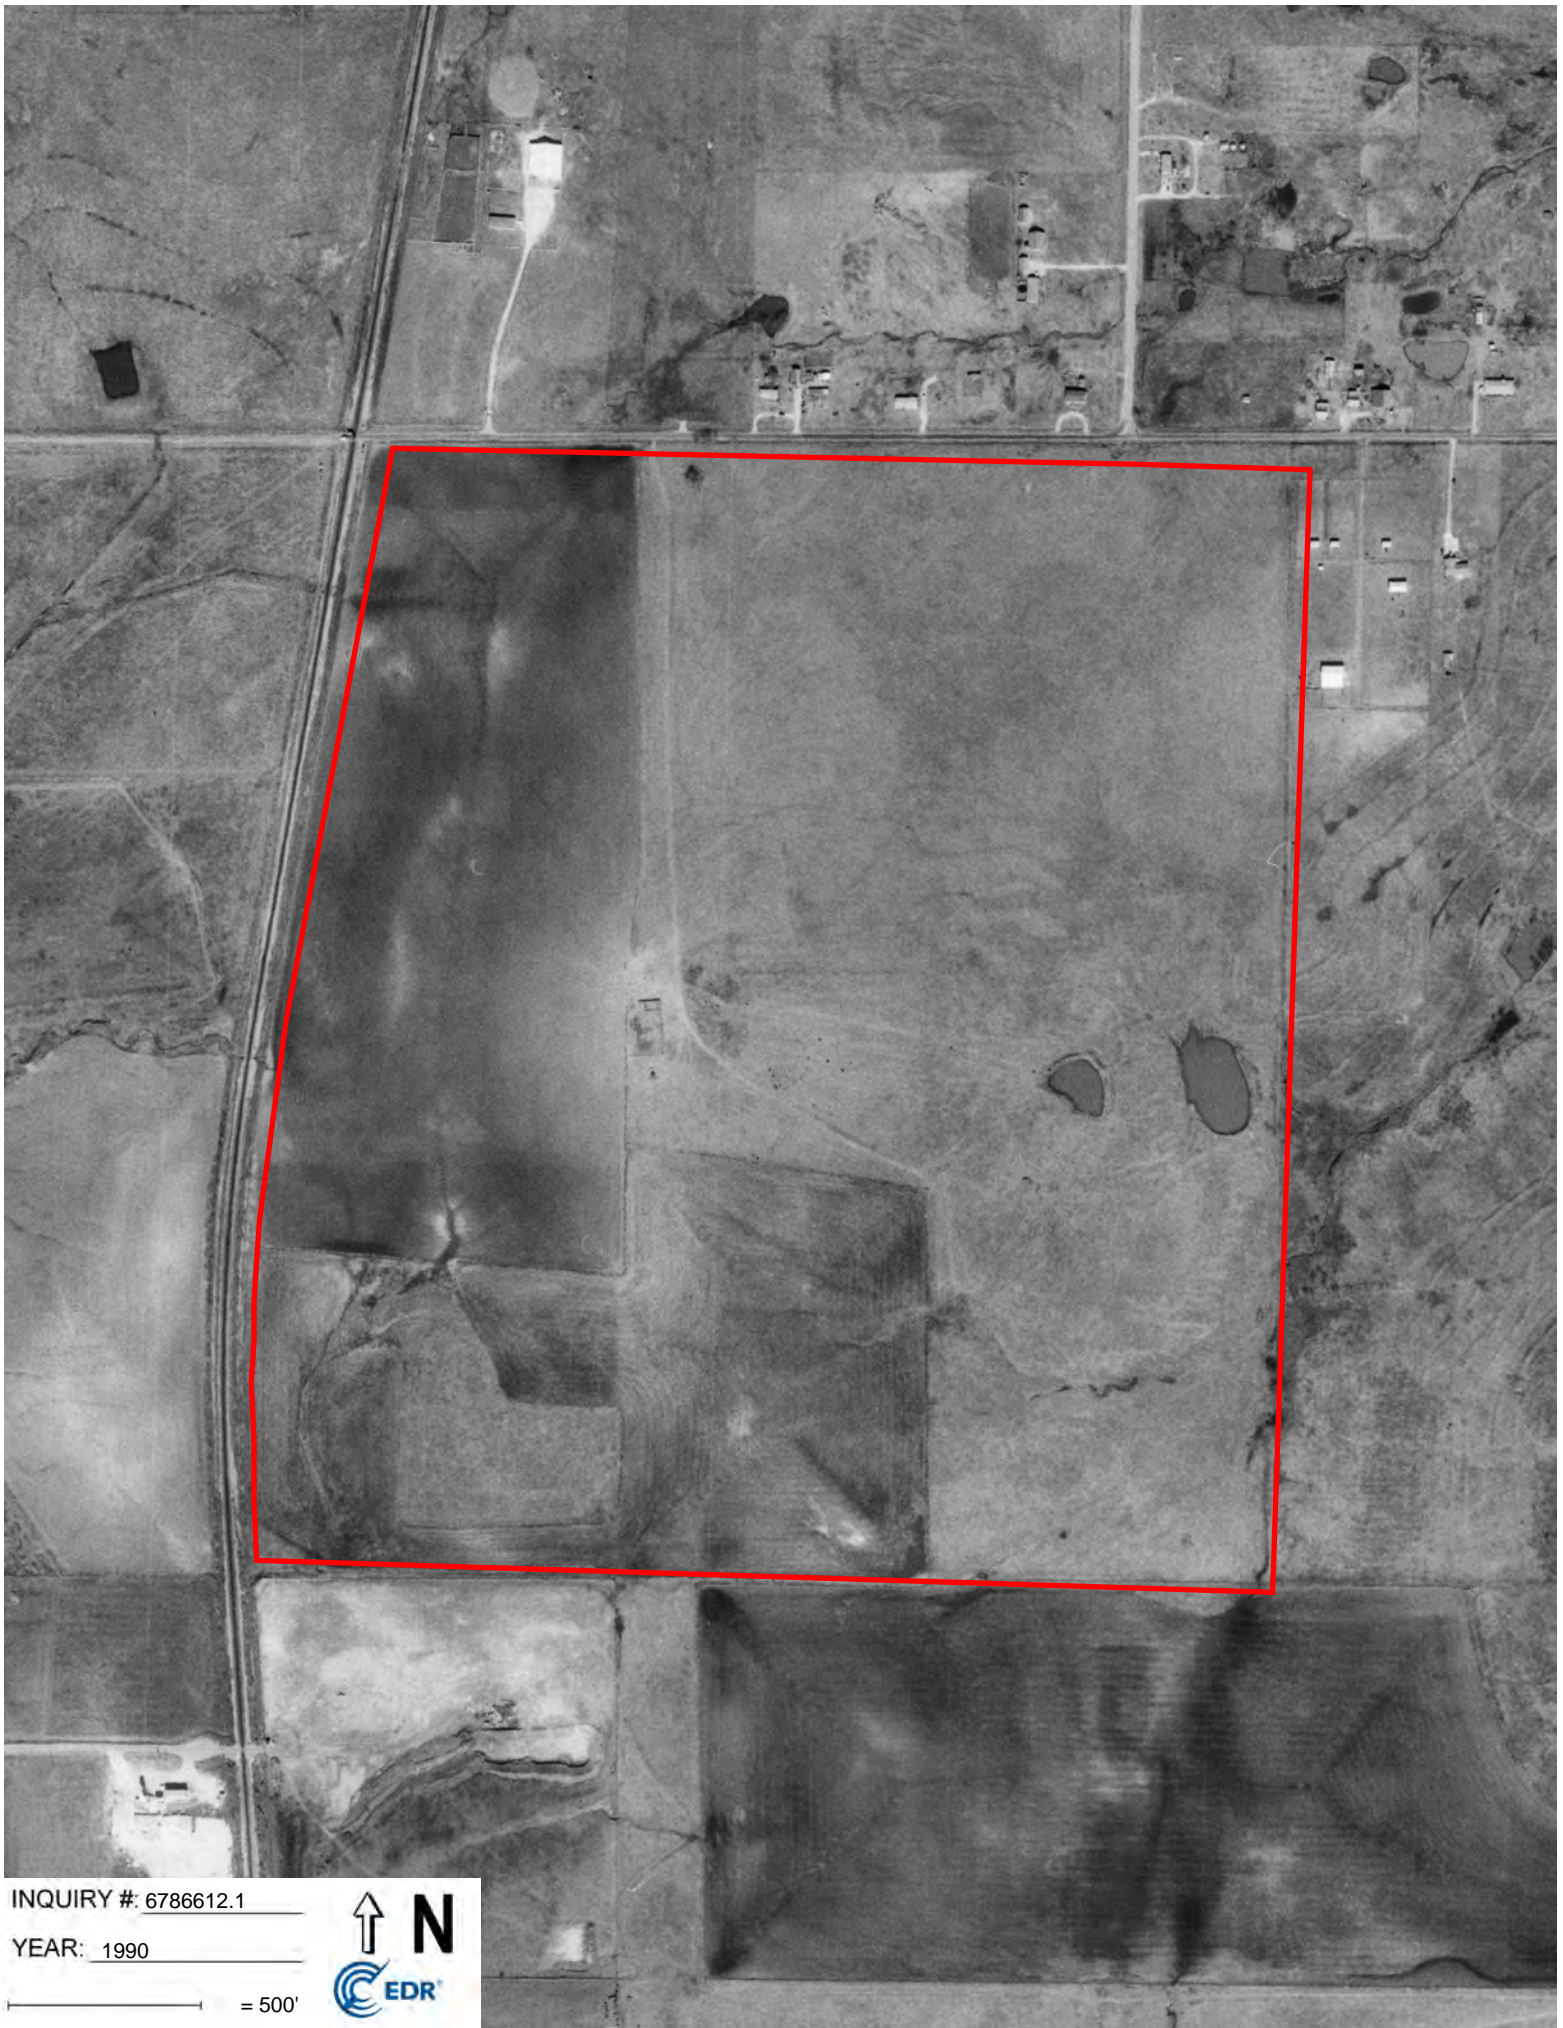
YEAR: 1990

1972-1990 – Several poorly-defined drainages are visible with scouring and vegetation that lack consistent OHWM indicators, one in the southwest that dissipates across the hillside to the southwest, another in the southeast that has a section of meandering scour in the location of the blue line feature on the USGS topographic map, but also dissipates downslope, and the beginning of a one is visible just to the west between the boundary and the railroad where the western blue line feature is illustrated on the USGS topographic map.

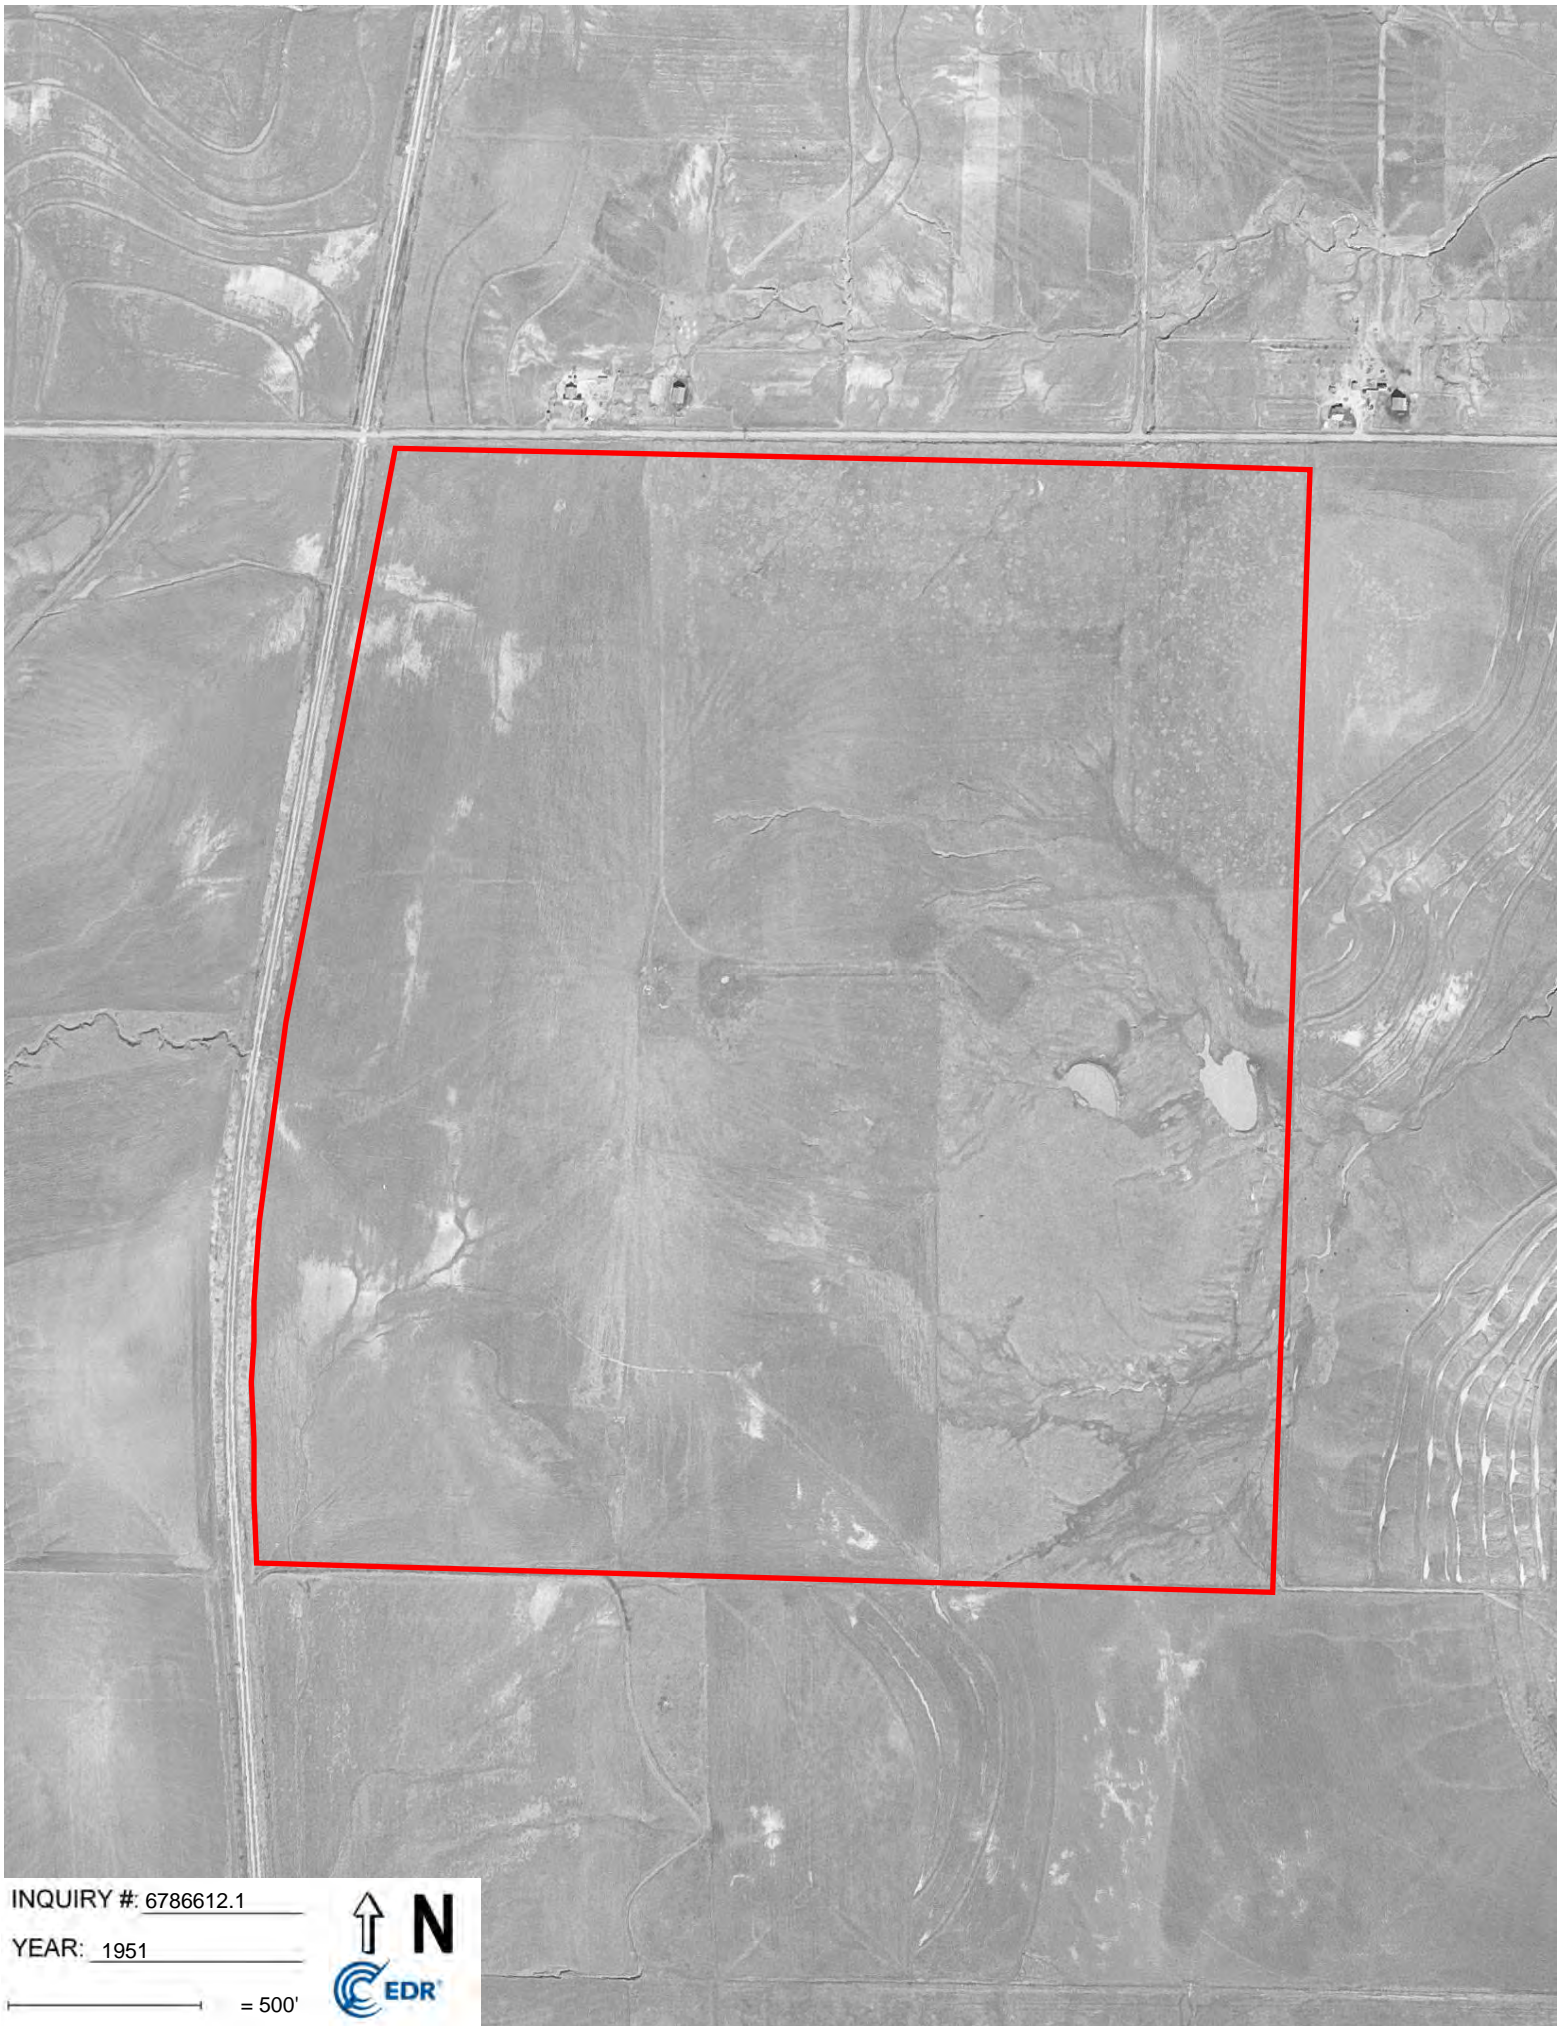
YEAR: 1951

1942-1951 – The survey area is characterized an active agricultural property comprised of plowed fields, pastureland, roadways, and stock ponds. Two isolated stock ponds are illustrated in the east-central portion and several weakly defined drainages indicate possible hillside erosion. Surrounding properties depict similar land use in addition to a railway bordering the western boundary.
