20 December 2021

Mark C. Spear, P.E.
Pape Dawson Engineers, Inc.
5810 Tennyson Parkway, Suite 470
Plano, Texas 75024

Re: Stephens Towne Center - Waters of the United States Delineation
Approximately 196+/- acres located at the southeast corner of Lois Lane and Interstate Highway
35 in the City of Sanger, Denton County, Texas

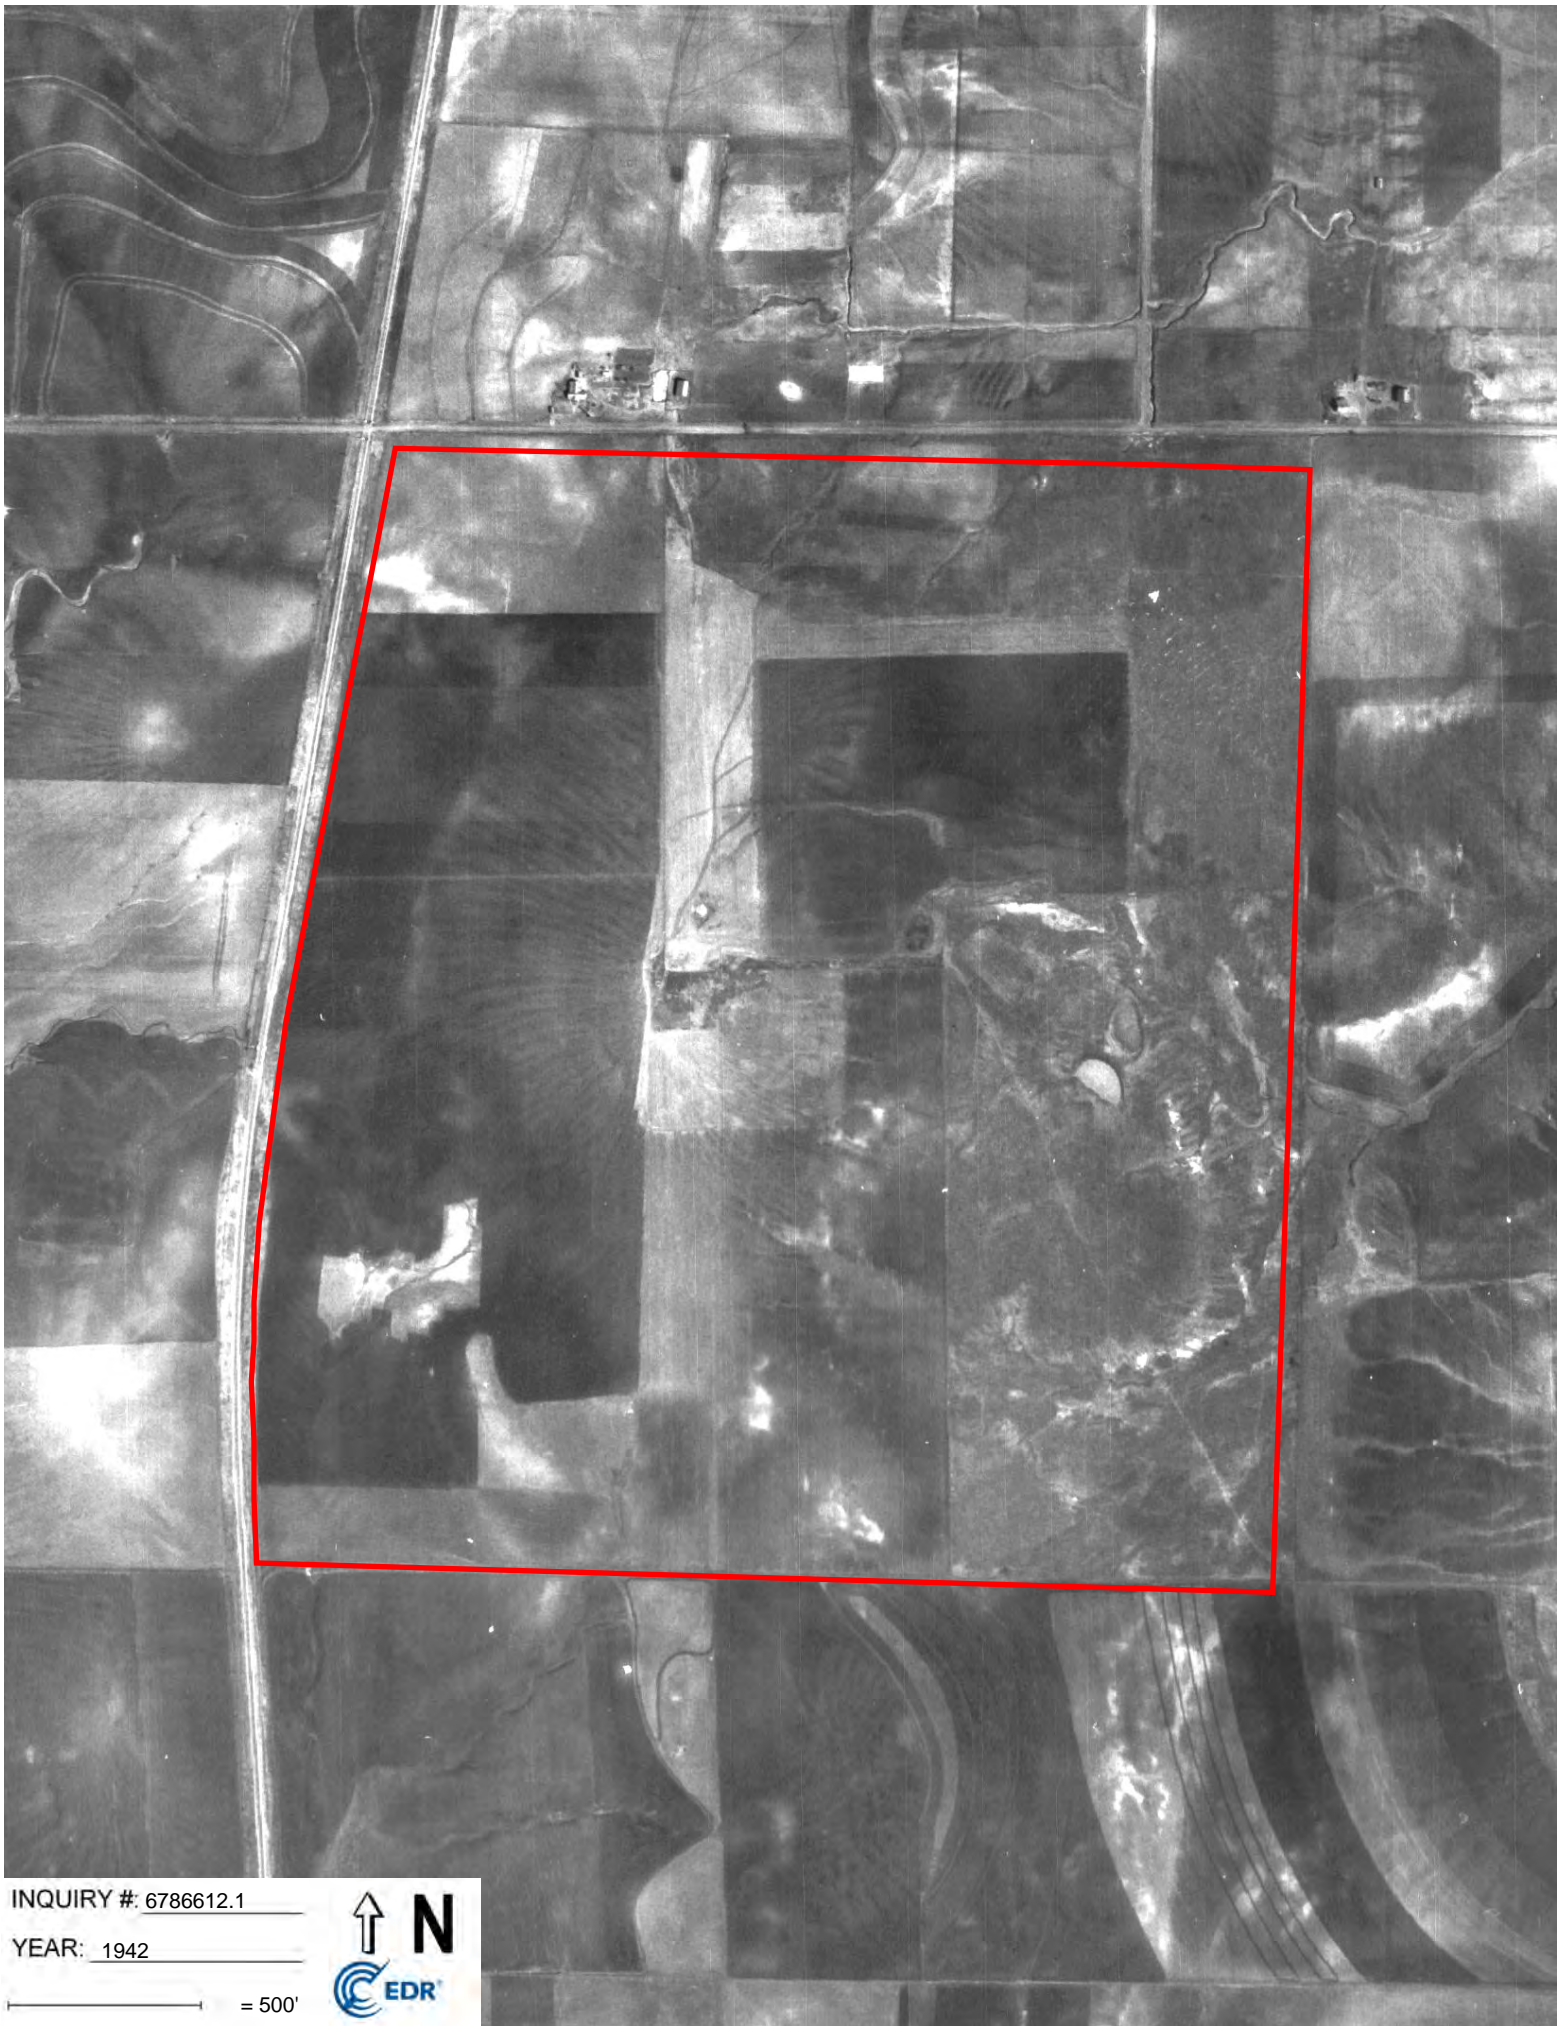
YEAR: 1942

1942-1951 – The survey area is characterized an active agricultural property comprised of plowed fields, pastureland, roadways, and stock ponds. Two isolated stock ponds are illustrated in the east-central portion and several weakly defined drainages indicate possible hillside erosion. Surrounding properties depict similar land use in addition to a railway bordering the western boundary.
